Property Inspection Report

Report Number: 676745

222 Nothing Happens Valley Rd
Lostburg, North Carolina

Date of Inspection: Wednesday, April 29, 2020

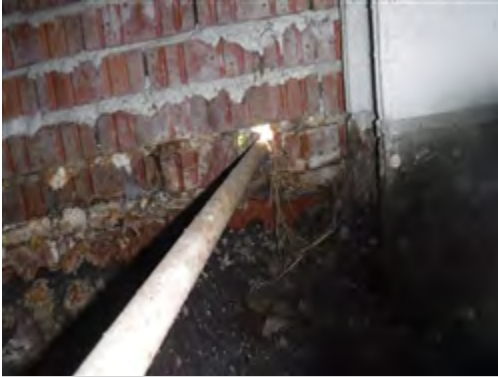
(A1 - 1.1) Main House

A hole in the foundation wall can allow vermin and storm water easy access to the crawlspace. A competent handy man can seal.

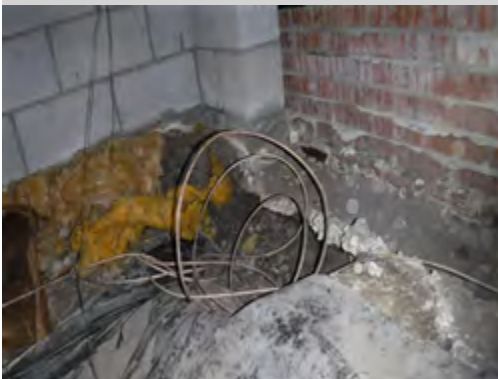
(A1 - 1.2) Main House

The footing has been exposed at the front right corner of the crawlspace. A competent handy man can fill as needed.

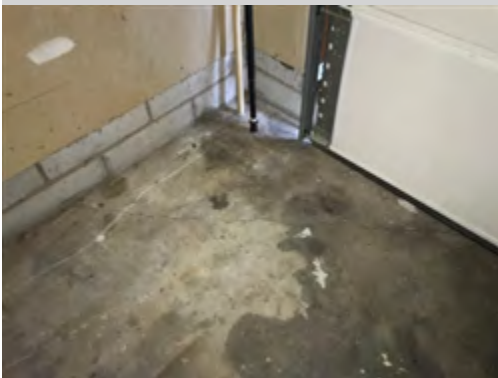
(A1 - 2.1) Garage

The garage slab is cracked at a couple locations. An engineer should be consulted for a complete evaluation, to determine the significance of the concern and outline necessary repairs.

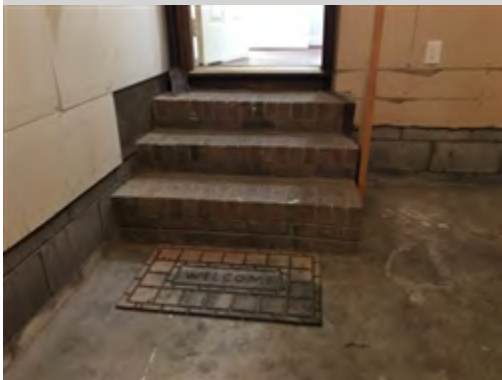
(A1 - 2.2) Garage

The steps at the entrance of the home have a noticeable variance in the height of the bottom step. This configuration could result in the trip or fall hazard as someone enters or leaves the home. A licensed general contractor should be consulted to review the steps and repair as needed to ensure safe access and egress.

The stairs do not have a handrail for safety. A qualified professional can install as desired.

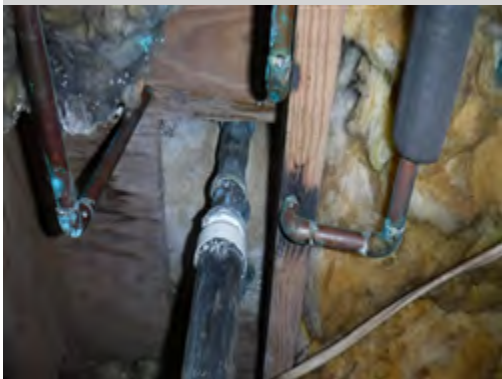
(A3 - 1.1) Main House

A floor joist has been drilled through to allow plumbing to be installed. No repairs were noted. I recommend a licensed general contractor investigate further and determine if repairs are necessary.

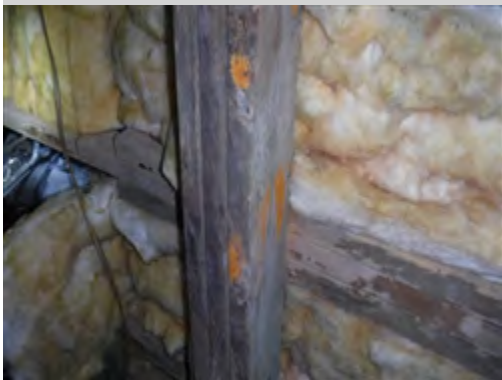
(A3 - 1.2) Main House

The floor system under the house has evidence of high moisture levels with organic growth. I recommend a licensed general contractor investigate further and recommend measures to mitigate the moisture levels. I further recommend subsequent observation to make sure any measures taken function long term.

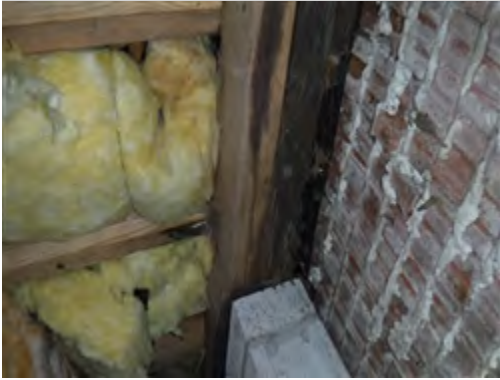
(A3 - 1.3) Main House

The floor structure along the back wall is water stained and damaged. Repairs have been made and the repairs also appear to have been stained. I recommend a sellers disclosure statement and subsequent observation. I recommend a licensed general contractor investigate further and determine if any further repairs are necessary.

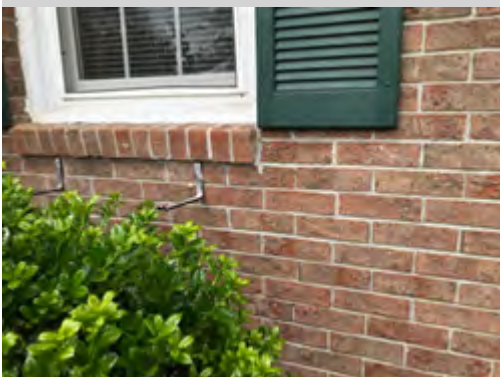
(B1 - 1.1) Main House

A crack was noted on the front wall. An engineer should be consulted for a complete evaluation, to determine the significance of the concern, and outline necessary repairs.

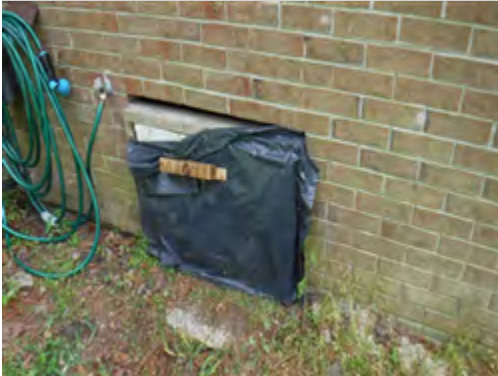
(B2 - 1.1) Doors

The crawlspace door does not close and secure properly to prevent vermin entering the crawlspace. A qualified professional can install/replace as needed.

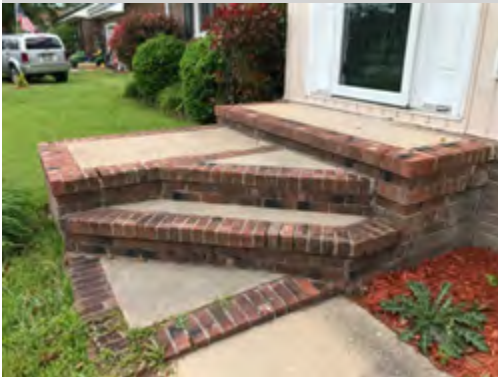
(B3 - 1.1) Stoop

The steps at the entrance of the home have a noticeable variance in the height of the steps. This configuration could result in the trip or fall hazard as someone enters or leaves the home. A licensed general contractor should be consulted to review the steps and repair as needed to ensure safe access and egress.

The steps do not have handrails to prevent accidentally falling or stepping off the floor surface. It is recommended that handrails be installed to ensure safe and functional use of the stairs. A licensed general contractor should be consulted for a complete evaluation and to make necessary repairs.

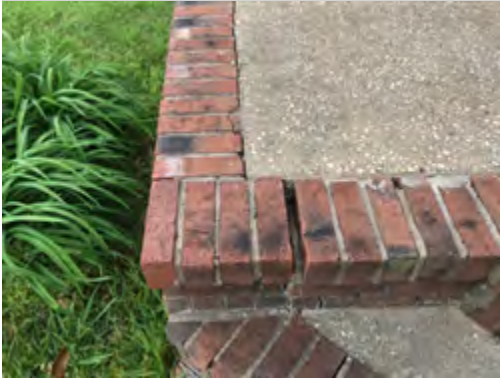
(B3 - 1.2) Stoop

The mortar joints for the front stairs need repair to prevent loose bricks and a trip hazard. A professional mason can repair.

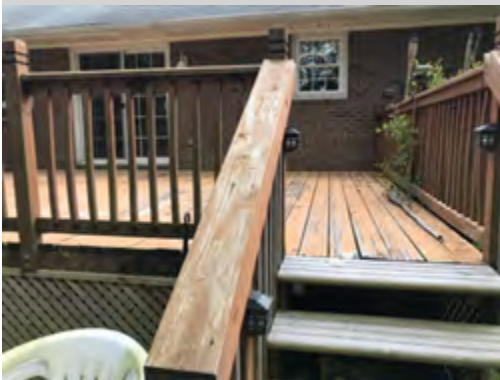
(B3 - 2.1) Deck

The top plate or grip that is installed on the handrails for the deck steps is too wide. The top plate should be within a size and thickness so that it can be easily gripped to prevent a fall. A licensed general contractor should be consulted for a complete evaluation of the deck and to make necessary repairs to ensure safe and functional use of the deck.

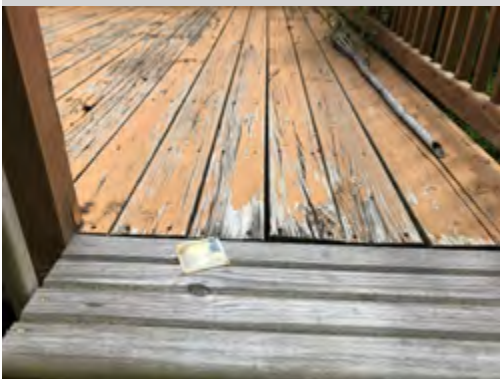
(B3 - 2.2) Deck

The wood deck was found to be severely weathered. Decking boards were splintering and cupped. This can present a safety hazard. A licensed general contractor should be consulted for a complete evaluation of the deck and to make necessary repairs to ensure the stability and durability of the deck.

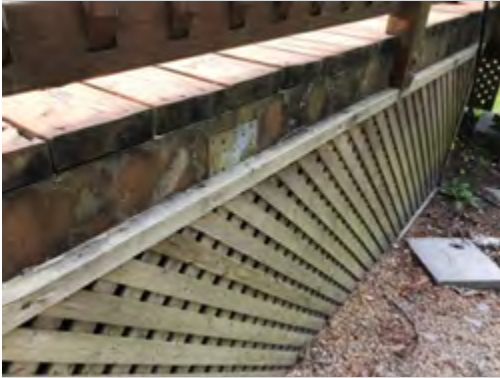
(B3 - 2.3) Deck

The outside support beam has an unsupported seam. A licensed general contractor should be consulted for further evaluation, to determine the extent of the damage, and to make necessary repairs.

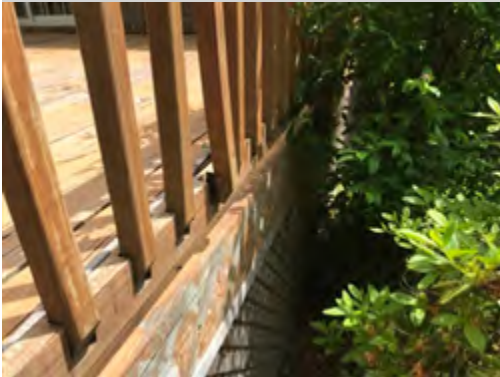
(B3 - 2.4) Deck

Multiple pickets are loose to the handrail. A competent handy man can secure.

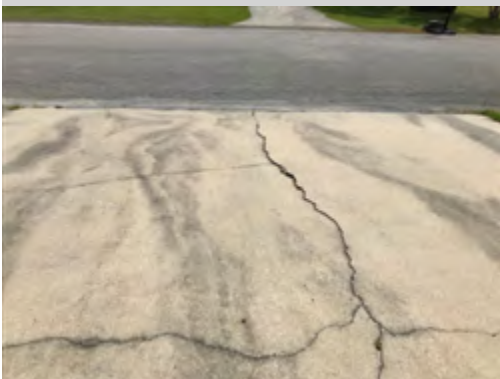
(B4 - 1.1) Driveway

The driveway is cracked and displaced. The raised section of the driveway has created a path for water penetration under the slab and a trip or fall hazard. A licensed general contractor should be consulted for further evaluation and repair.

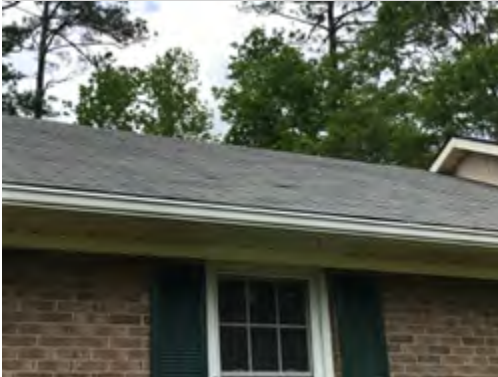
(C1 - 1.1) Main House

The shingles are being pushed up at multiple locations by nails. This can damage the shingles and expose the shingles to wind damage. A professional roofer can repair/secure as needed.

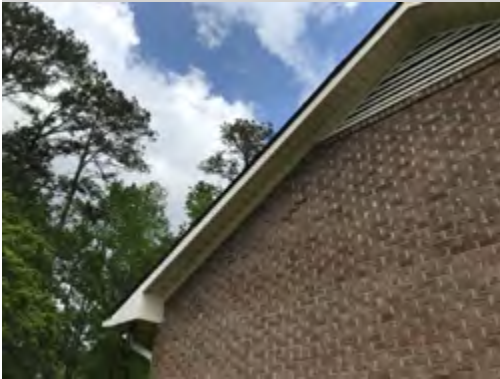
(C3 - 1.1) Main House

Both the fascia roof rake trim and the drip edge have been installed incorrectly which can trap moisture behind the trim. A professional siding installer can investigate further and determine if repairs are necessary.

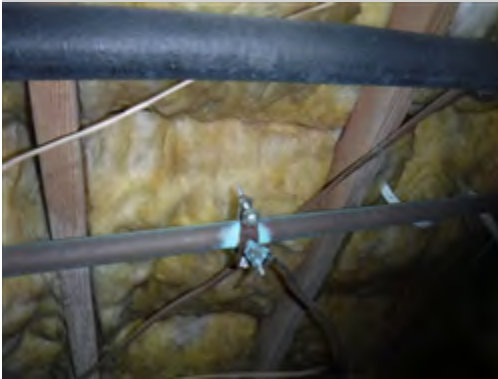
(D1 - 1.1) All Accessible Areas

The plumbing distribution lines have visible corrosion at the fitting to the refrigeration line. A licensed plumbing contractor should be consulted for complete evaluation of the water supply and distribution systems to determine the general condition of the system and to make necessary repairs.

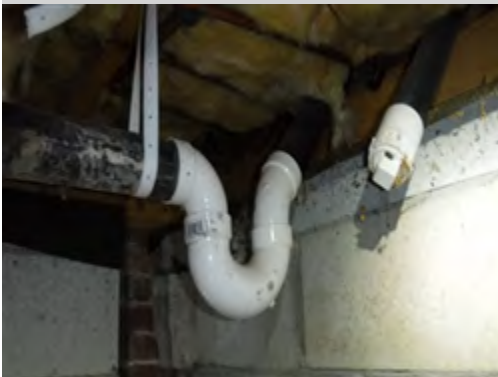
(D2 - 1.1) All Accessible Areas

The waste line has been repaired by gluing PVC and ABS pipes together. This is not a recommended connection and often fails with age resulting in leaks. A licensed plumbing contractor should be consulted for a complete evaluation of the waste line systems to determine the general condition of the system and to make necessary repairs.

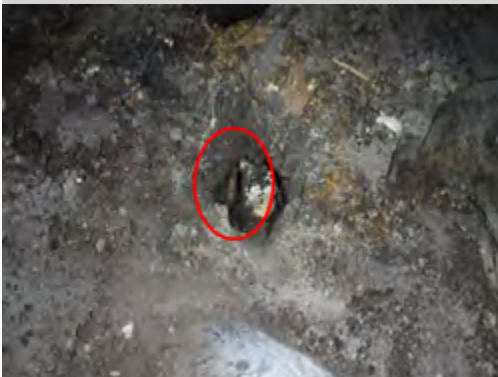
(D2 - 1.2) All Accessible Areas

The waste line just inside the crawlspace door is separated. This is allowing soil to enter the system and drain lines and waste water to enter into the crawlspace. Plumbing issues should be corrected prior to purchasing the home to prevent leaking or future problems and ensure sanitary conditions. A plumbing contractor should be consulted for a complete evaluation of the system and to make necessary repairs.

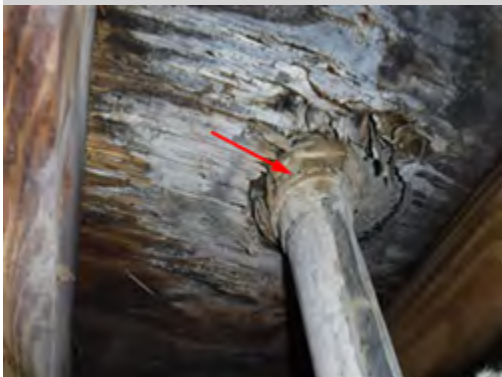
(D2 - 1.3) All Accessible Areas

The main waste line is leaking around the master shower. The waste line needs to be repaired to ensure sanitary conditions. A licensed plumbing contractor should be consulted for complete evaluation and of the waste line systems to determine the general condition of the system and to make necessary repairs.

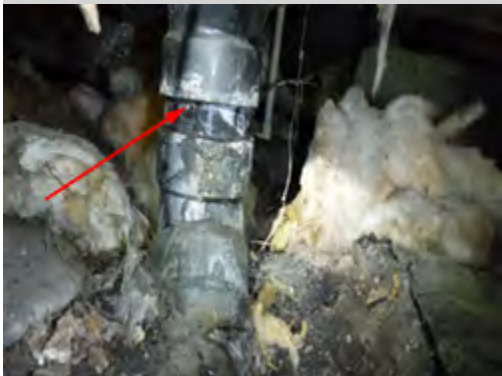
(D2 - 1.4) All Accessible Areas

The main waste line is leaking. The waste line needs to be repaired to ensure sanitary conditions. A licensed plumbing contractor should be consulted for complete evaluation and of the waste line systems to determine the general condition of the system and to make necessary repairs.

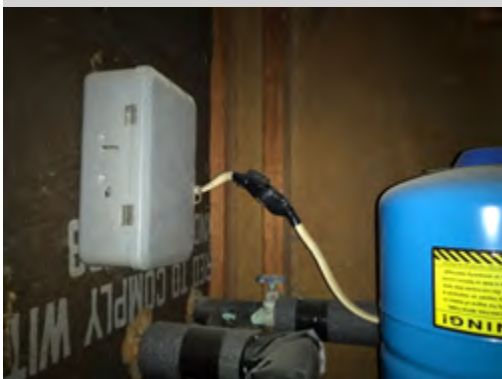
(D3 - 1.1) Unit 1

A wire connection next to the water heater is missing a junction box. A licensed electrician can install.

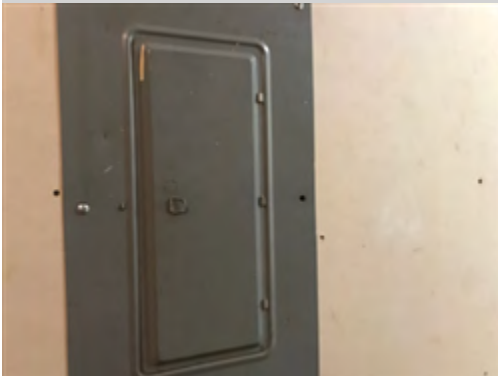
(E2 - 1.1) Main Panel Garage

The cover panel is missing a screw to secure to the cover properly. A competent handy man can install.

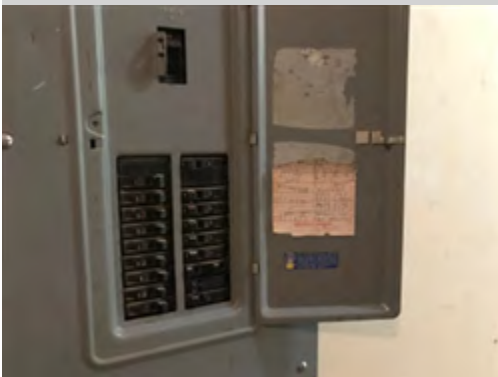
(E2 - 1.2) Main Panel Garage

The service breakers in the panel are not properly identified or labeled. Proper labeling ensures adequate service for appliances and sub-panels and the overall safety of system when emergencies occur or repairs are needed. Without proper labels the inspector's ability to evaluate and inspect system is greatly reduced. A licensed electrical contractor should be consulted for a complete evaluation to label all electrical panels, subpanels, and service breakers and verify the compatibility of the configuration, and the main service disconnect.

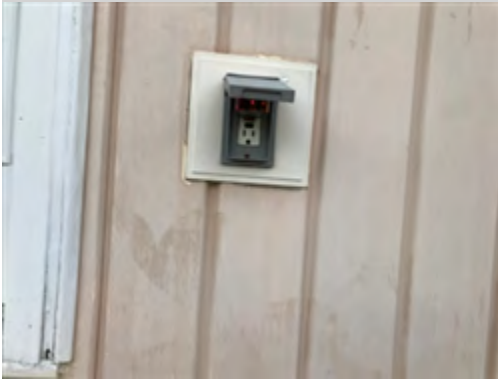
(E5 - 1.1) Exterior

The GFCI receptacle(s) did not test/reset correctly to ensure that it was ground fault protected. GFCI protection is needed to reduce shock in hazardous locations.

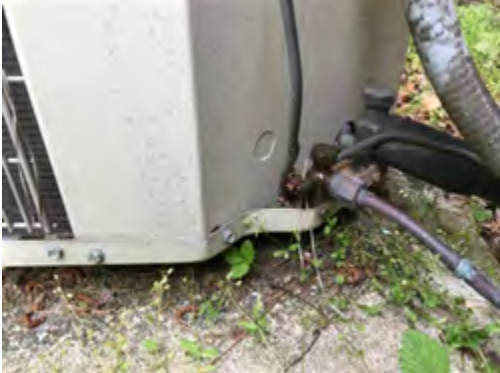
(G1 - 1.1) Cooling Unit 1

The Freon line is missing the fill cap. A competent HVAC mechanic can install.

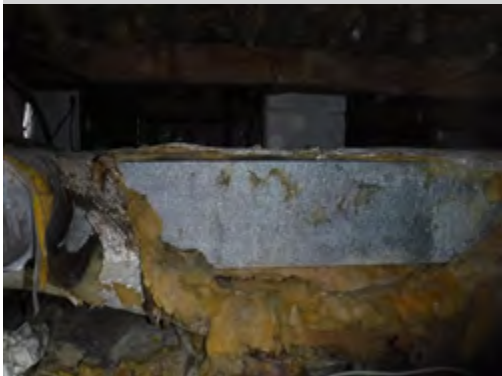
(G2 - 1.1) Cooling Unit 1

The insulation around the HVAC duct system is loose/falling off. This can expose the inner liner to damage. A licensed HVAC mechanic can investigate further and repair/replace as needed.

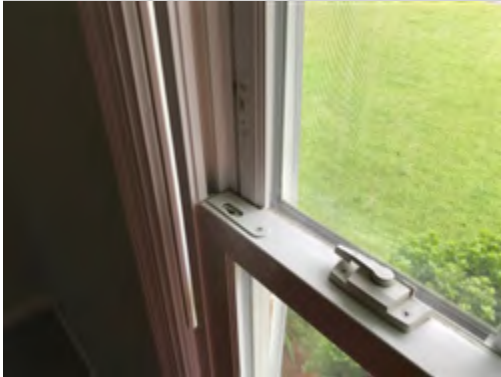
(H1 - 3.1) Bedroom Left

The windows in the home tilt after opening for cleaning. When the windows are snapped back into place after tilting the tilt lock does not engage. When the window tilt lock is not engaged the window sash can fall forward and cause personal injury. A general repair specialist or licensed general contractor should be consulted for evaluation and repair.

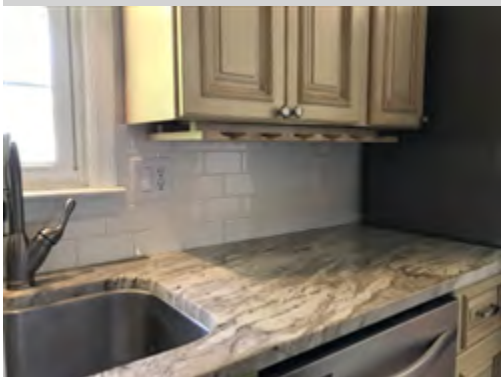
(H2 - 1.1) Kitchen

The GFCI receptacle(s) did not test/reset correctly to ensure that it was ground fault protected. GFCI protection is needed to reduce shock in hazardous locations.

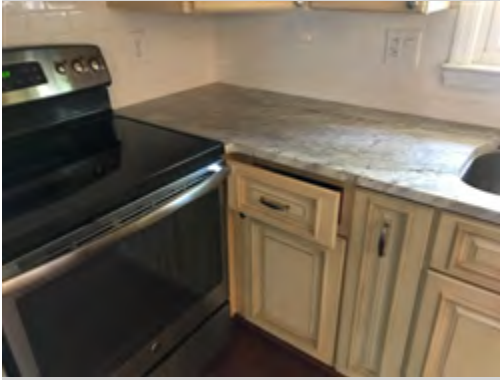
(H2 - 1.2) Kitchen

A drawer next to the range does not open because of the oven door.

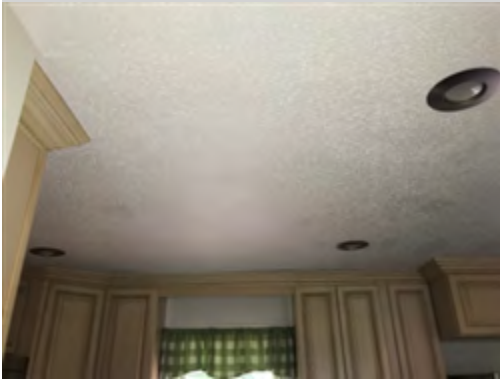
(H2 - 1.3) Kitchen

Evidence suggest repairs to the ceiling have been made. I recommend a sellers disclosure.

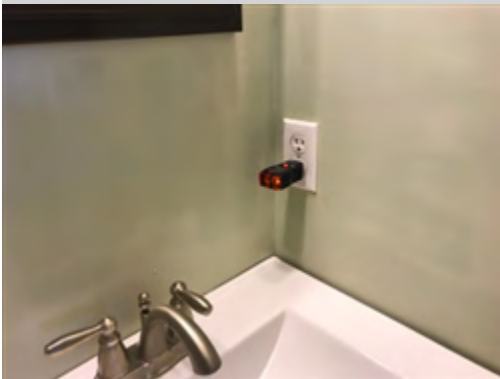
(H3 - 1.1) Bathroom: Master

The receptacle(s) is/are not GFCI protected. Receptacles located in hazardous or wet locations should be GFCI protected to reduce shock in hazardous locations. A licensed electrical contractor should be consulted for further evaluation and repair.

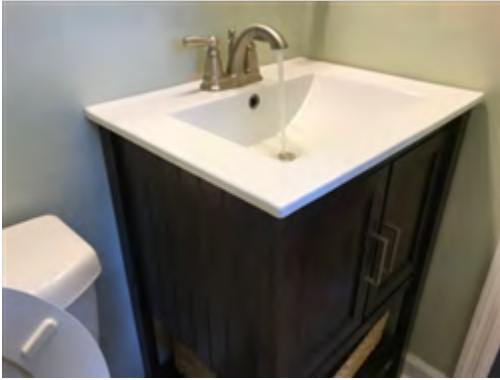
(H3 - 1.2) Bathroom: Master

The sink cabinet is not securely mounted. Movement of the fixture could result in personal injury or plumbing system damage. A general repair specialist should be consulted for evaluation and repair.

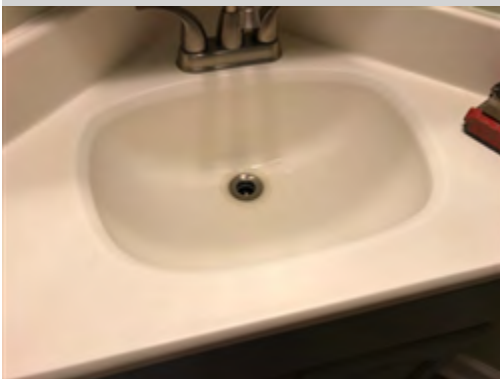
(H3 - 2.1) Bathroom Hall

The bathroom sink stopper does not function properly. A competent plumber can repair/adjust as needed.

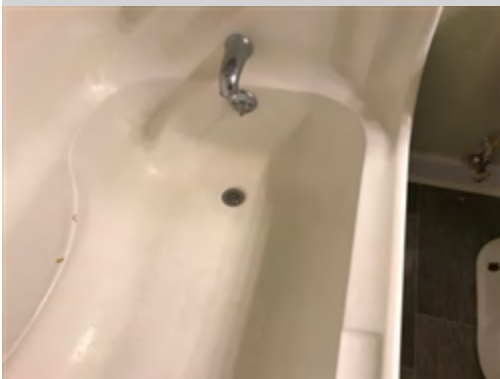
(H3 - 2.2) Bathroom Hall

The bathroom tub stopper does not function properly. A competent plumber can repair/adjust as needed.

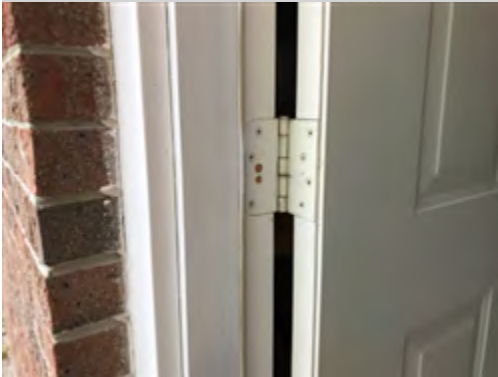
(H4 - 1.1) Garage

The exterior door is missing a screw in the hinge. This can affect the operation of the door. A competent handy man can secure/install as needed.

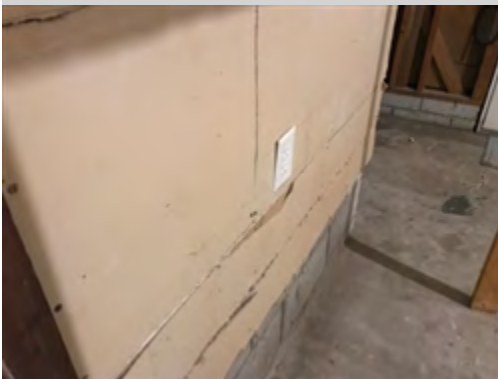
(H4 - 1.2) Garage

The receptacle(s) is/are not GFCI protected. Receptacles located in hazardous or wet locations should be GFCI protected to reduce shock in hazardous locations. A licensed electrical contractor should be consulted for further evaluation and repair.

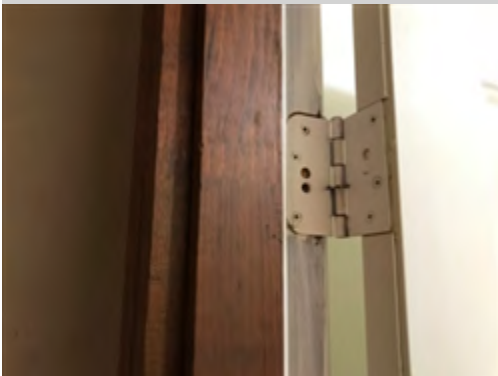
(H4 - 1.3) Garage

The door to the home is missing a screw in the hinge. This can affect the operation of the door. A competent handy man can secure/install as needed.

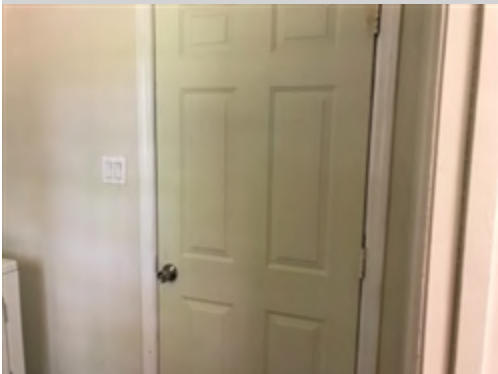
(H4 - 1.4) Garage

The door to the home is not insulated and a fire rated door. I recommend a professional carpenter investigate further and determine if replacement is necessary.

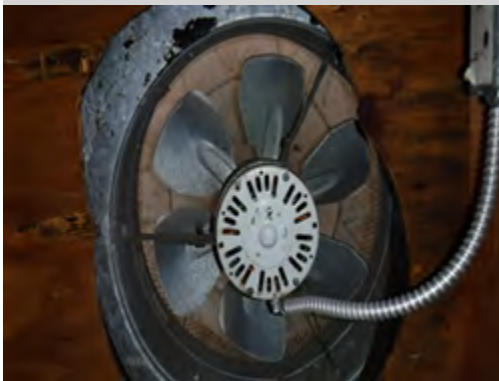
(I1 - 1.1) Attic

The attic fan did not function when tested. Damaged fan units can cause ventilation problems and present fire hazards. A licensed general contractor should be consulted for repair/replacement.

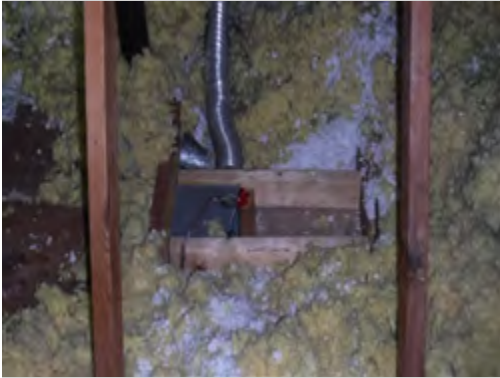
(I1 - 1.2) Attic

The insulation is compressed or displaced. The effectiveness of the insulation is reduced when displaced or compressed. Improper insulation installation could result in condensation, over heating of the building components, and inadequate conditioning of the living areas. A licensed general contractor should be consulted for repair/replacement.

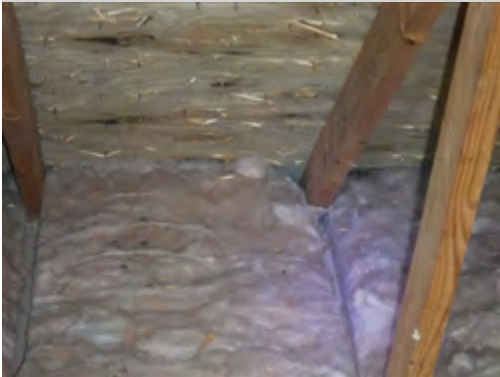
(I1 - 1.3) Attic

The insulation is blocking the soffit vents. The insulation was not installed with baffles to prevent movement to unheated areas. Improper insulation installation could result in condensation, over heating of the building components, and inadequate conditioning of the living areas. A licensed general contractor should be consulted for repair/replacement.

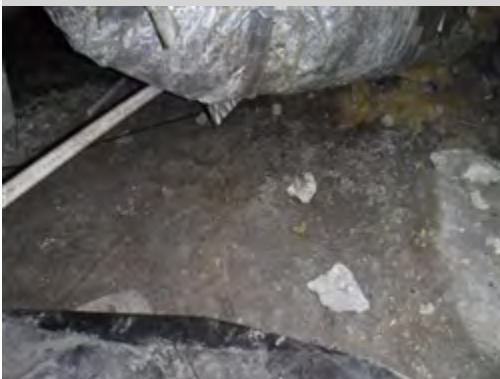
(I1 - 2.1) Crawl Space

The vapor barrier is not properly covering the ground. This can lead to high moisture issues in the crawlspace. A qualified can investigate further and determine if repairs/adjustments are necessary.

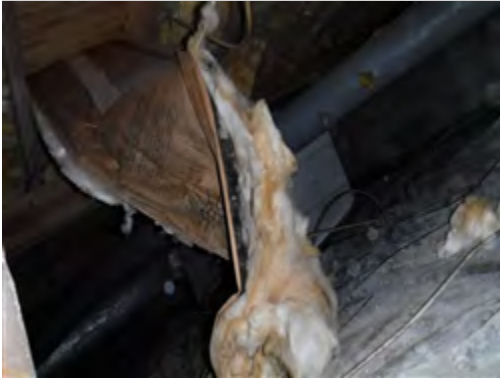
(I1 - 2.2) Crawl Space

The insulation in the crawlspace is falling at multiple locations. This can damage the insulation and affect the insulation value of the home. A competent handy man can repair/install as needed.
